Office of the Chief of Naval Research  
Contract N00014-87-K-0326 ✓  
Technical Report No. UWA/DME/TR-89/1

## Spall Resistance of Alumina

L.R. Deobald, M. Taya, A.S Kobayashi, and H.S. Yoon

September 1989

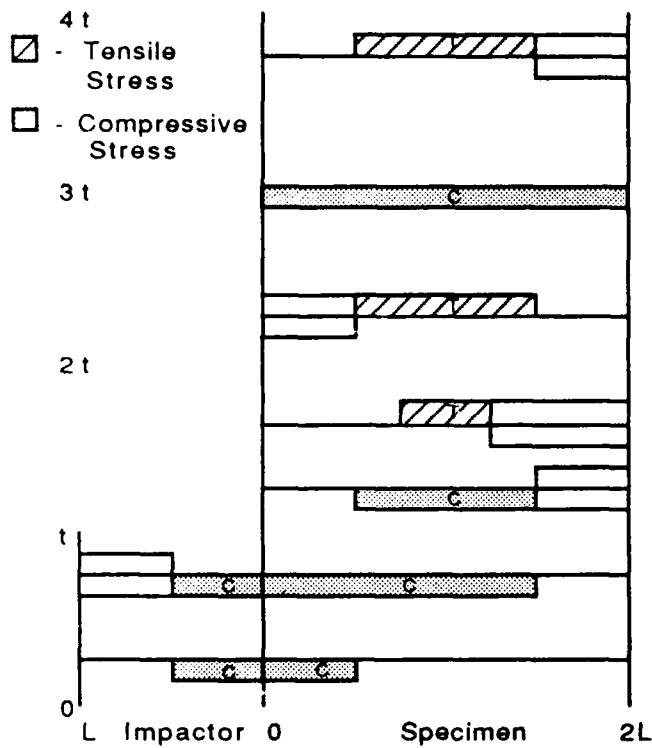
Figure 1, Wave propagation schematic in a plate impact test.

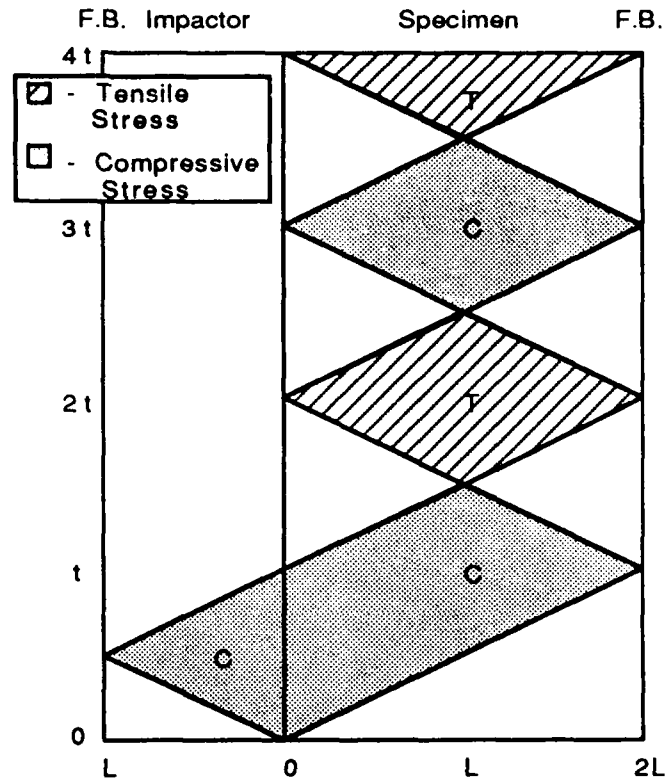
Figure 2, Characteristic diagram of the wave fronts (Lagrangian diagram).

Experience with metals shows that spall damage can occur at the location of maximum stress and is a function of the tensile stress amplitude and pulse duration [2]. Based on the Lagrangian diagram, the region of maximum damage due to the stress pulse is located in the middle region of the specimen. Plate impact experiments on MgO crystals generated microcracking near the midplane[3], and plate impact experiments on Cu-SiO<sub>2</sub> crystals produced microvoid formation near the midplane[4]. Alumina has been tested extensively by high velocity plate impact experiments[5-11]. The spall strength of alumina was reported to be dependent on the tensile stress amplitude and strain rate. Microcracks can be "trapped" in brittle materials when the pulse duration is sufficiently short.

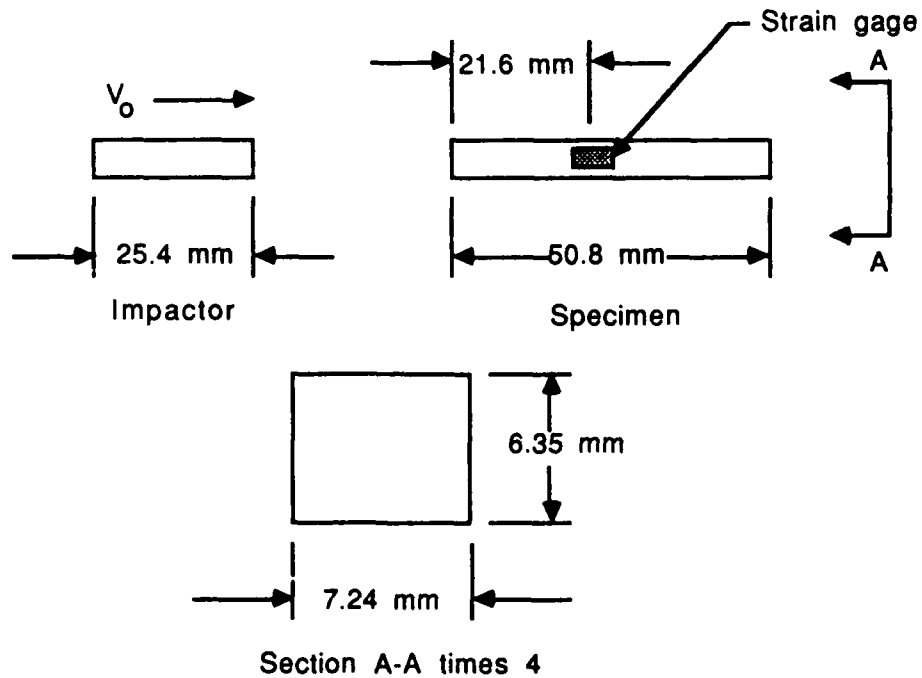
Figure 3, Specimen Geometry and Strain Gage Location.

Since the current work requires fracture toughness testing, an impact technique was developed which employs a 50.8 mm bar specimen which is impacted on one end by a bar of half the length (See Fig. 3). The impact apparatus, shown in Figure 4, consists of an air gun, pneumatic controls, and the impact system. The impact carriage, which contains the impactor, is propelled down the guide rails towards the specimen carriage. The impactor first collides with the specimen. Prior to collision of the plastic pieces, the elastic wave traverses the specimen length several times. A sawdust filled catch box receives the airborne specimen.

A strain gage (M-M CEA-06-064UW-350) was mounted 21.6 mm from the impact face in order to monitor the transient strain wave. Since the strain pulse has only a 6.2  $\mu$ sec duration, the measurement system had to have at least a 10 MHz response. The gage was a part of a potentiometer circuit which incorporated a high band pass filter (See Fig. 5). The ten gain amplifying circuit had a 20 MHz response, and the digital oscilloscope was set to 20 MHz. Since the strain gage has a finite gage length, it will average a rapidly varying signal over its gage length [12,13]. One may either correct the distortion or simply keep the gage length as small as possible in order to minimize the distortion [12]. The gages which were used had a 1.6 mm gage length. Smaller gages could not be employed since they could not dissipate enough heat on the specimens of poor heat conductivity. Excessive current will thermally damage the strain gage [13,14]. Data acquisition programs have been written for a wave form which is to be stored on the computer disk, sent to the oscilloscope for accurate time, strain, and strain rate measurements, and allows a portion of the wave form to simulate propagation in the specimen.

The specimens were precision cut and ground to the dimensions shown in Figure 3. Since the specimens were to be examined under a scanning electron microscope (S.E.M.), one side surface of the specimen was polished prior to testing. Polishing was performed on a flat glass plate using 6 micron and 1 micron diamond paste.

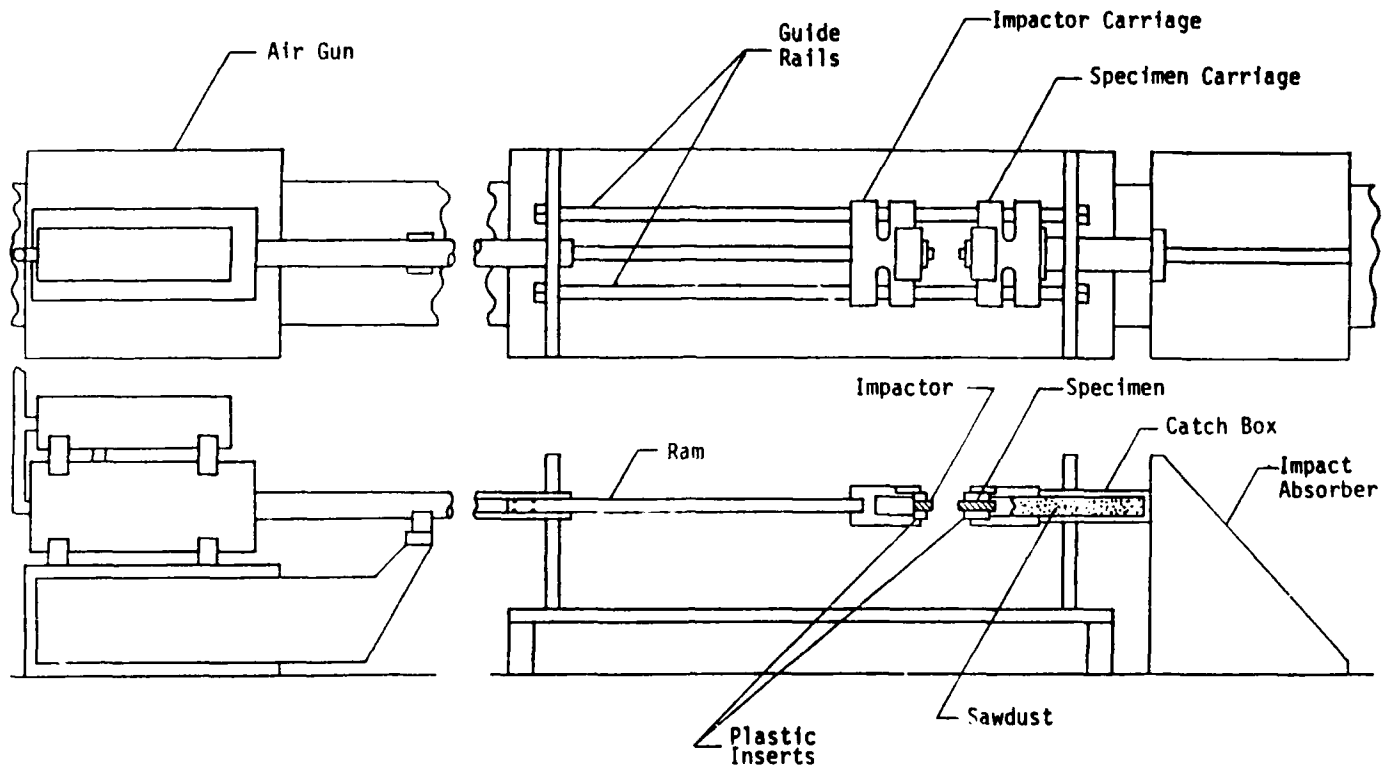
## CROSS SECTION PROFILE VIEW

Figure 4, Impact Apparatus, including airgun, impact carriage, specimen carriage.

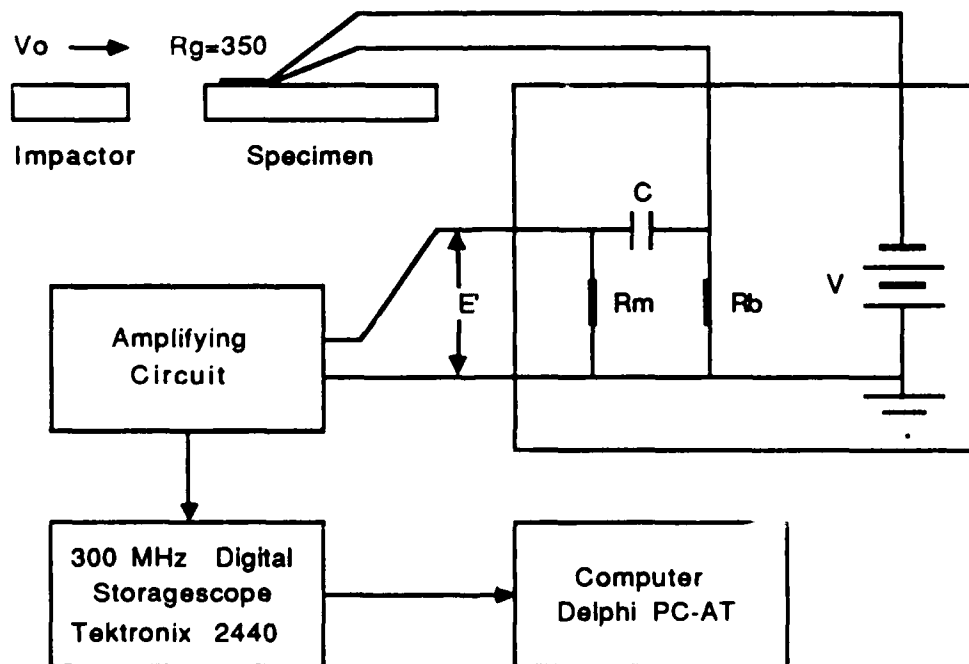
Figure 5, Strain Gage Circuit;  $R_b = 562 \Omega$ ,  $V = 15$  volts

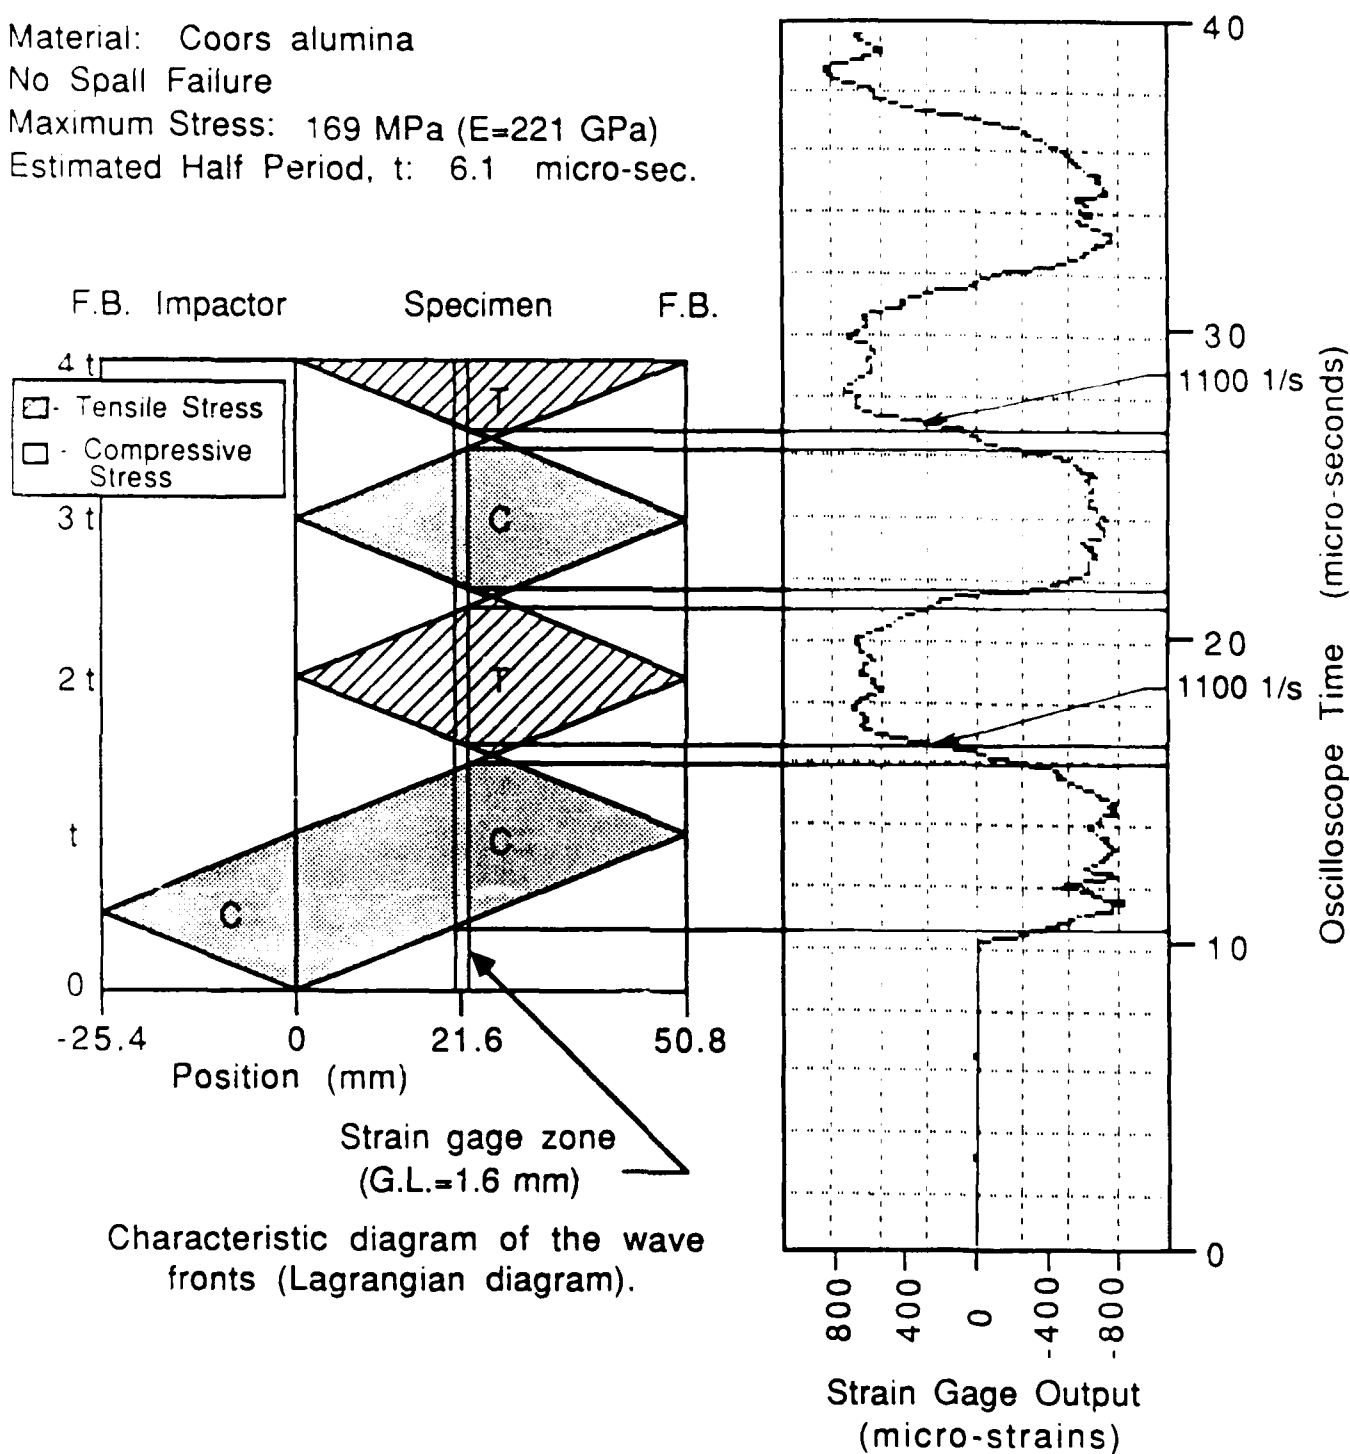
# Strain History of Bar Impacted at 12.2 m/s

No Spall Failure

Maximum Stress: 169 MPa ( $E=221$  GPa)

Estimated Half Period,  $t$ : 6.1 micro-sec.

Figure 6, Correlation of measured strain with Lagrangian diagram; velocity = 12.2 m/s.

The strain wave record is correlated with the Lagrangian diagrams in Figures 6 and 7 for the impact velocities of 12.2 m/s and 14.0 m/s. The wave forms are basically square as predicted by elementary bar theory, and the higher frequency oscillations are apparent which is attributed to the lateral inertia. The wave forms compare closely to experimental results for long rods obtained by Miklowitz[15]. The "zero strain" periods predicted by the Lagrangian diagram did not appear due to the three dimensional effects. As expected, the first compressive pulse has the longest "true" duration. Interestingly, the spalled specimen impacted at 14.0 m/s failed on the second cycle of tension. This was consistent among all specimens which failed by complete spall and supports the theory of cumulative damage.

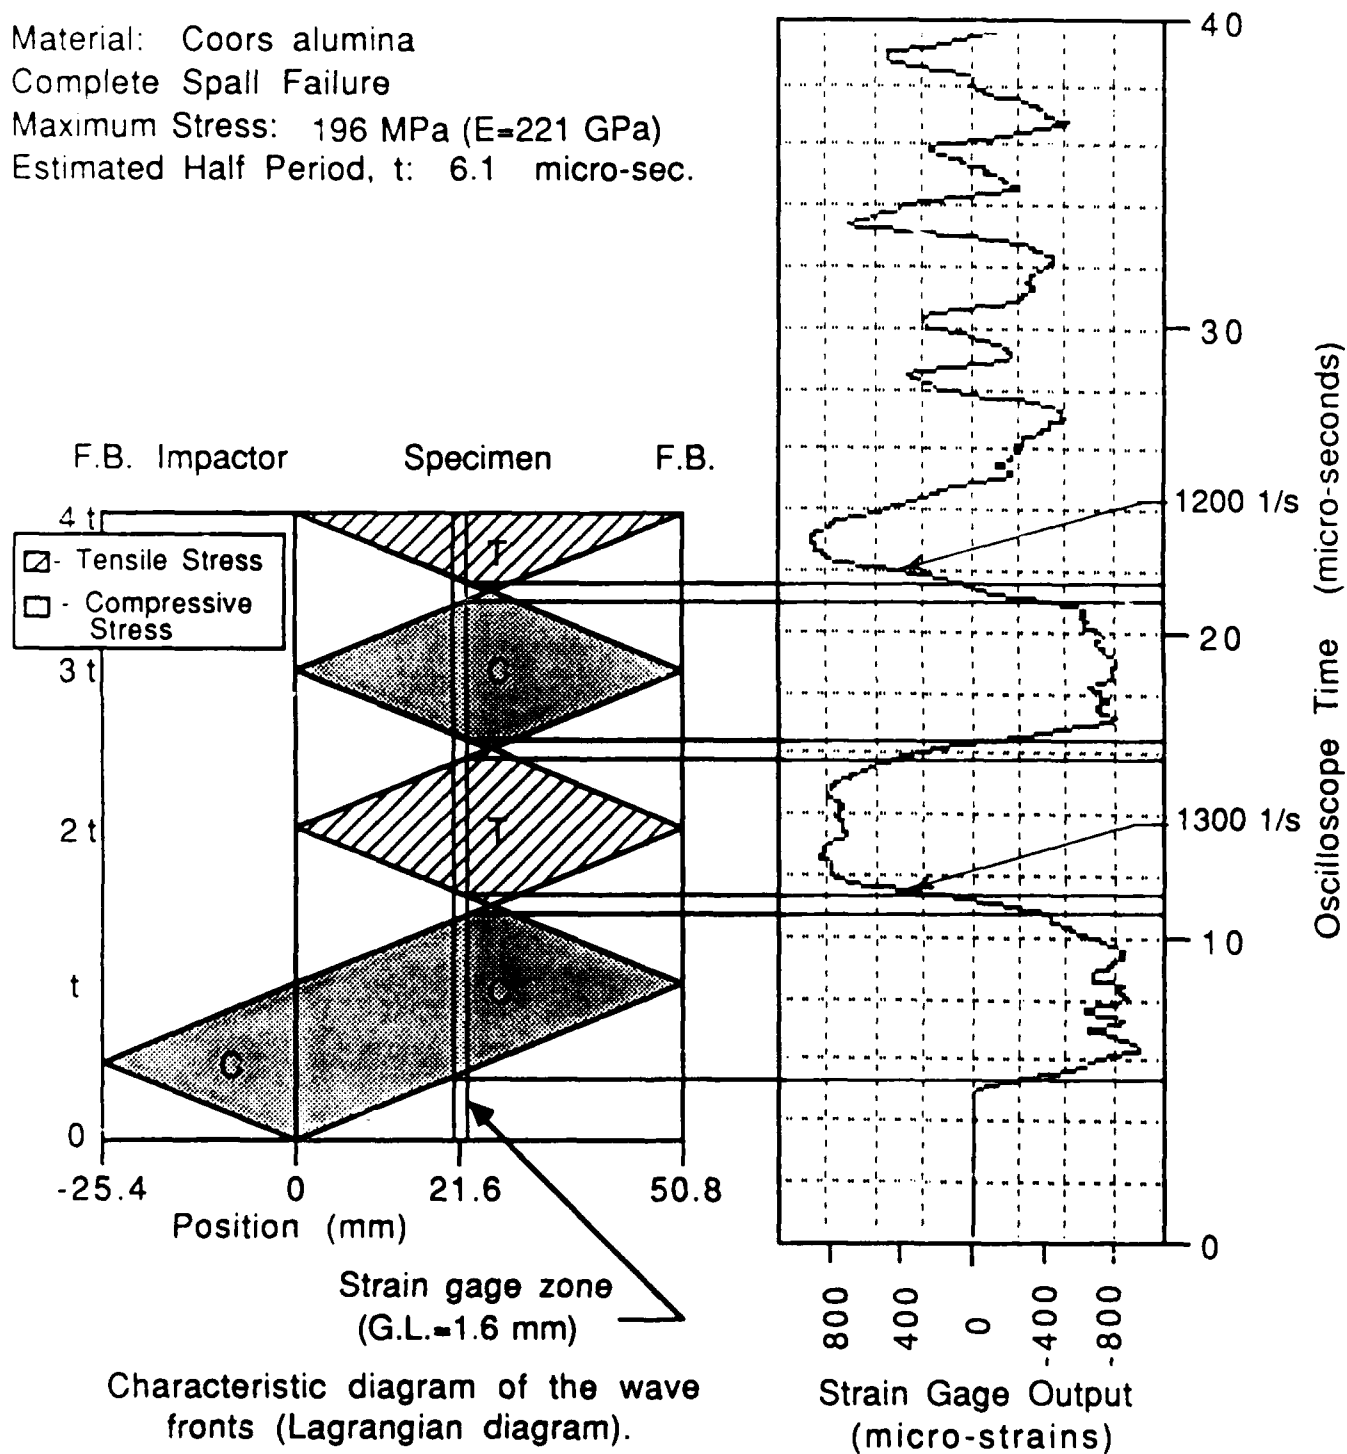
# Strain History of Bar Impacted at 14.0 m/s

Complete Spall Failure

Maximum Stress: 196 MPa ( $E=221$  GPa)

Estimated Half Period,  $t$ : 6.1 micro-sec.

Figure 7, Correlation of measured strain with Lagrangian diagram; velocity = 14 m/s.

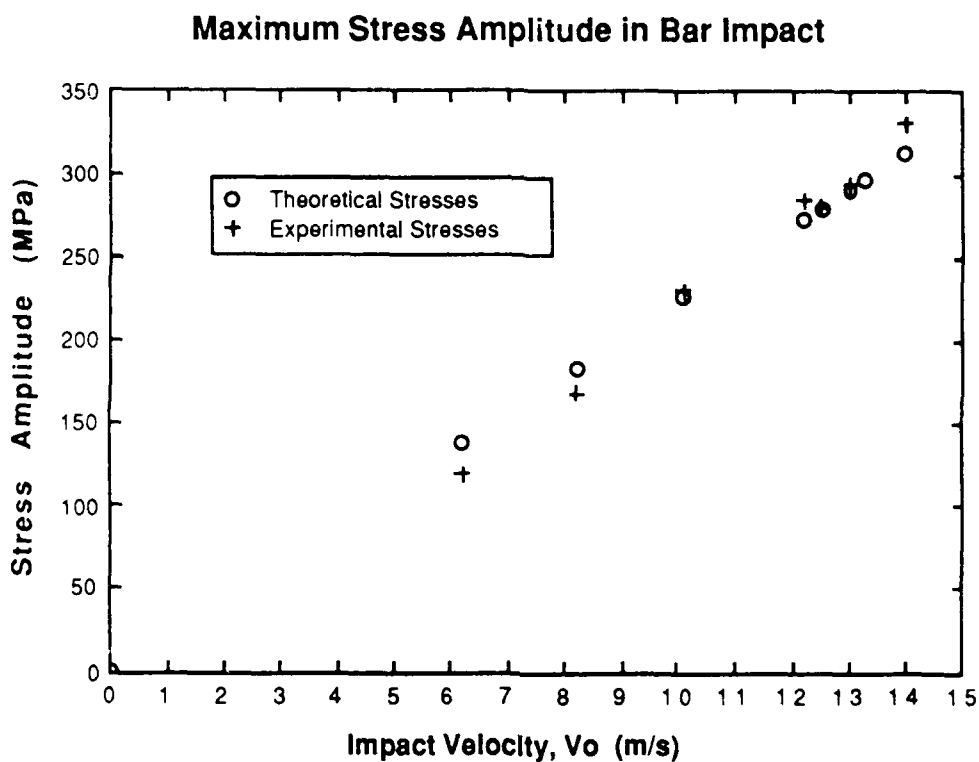
Figure 8, Measured and predicted stress level.

Figure 8 displays the predicted and experimentally determined stresses plotted against the impact velocity. The predicted stress was calculated using Equation (1) with the measured impact velocity and wave speed, and the stress was obtained from the measured strain. Both values used the manufacturers value of Young's modulus (see Table 1). Some question arose in the measurement of the strain level since lateral inertia effects cause jagged wave forms. The measurement was taken at the peak values, but wave theory indicates that this could lead to stress values which are 27% too high (see Ref. 15).

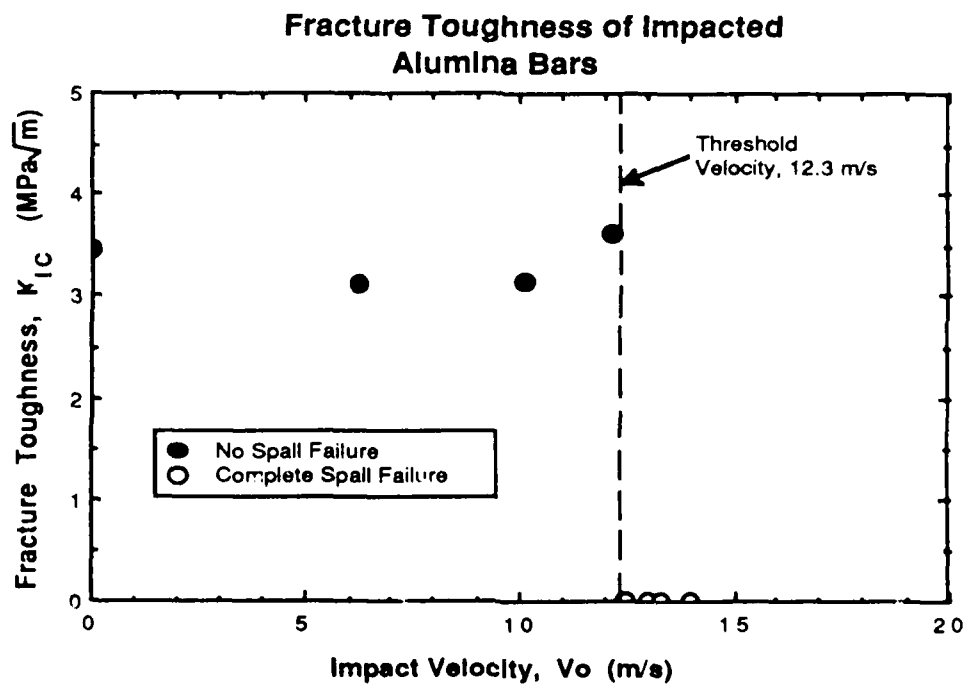
Figure 9, Fracture toughness as a function of impact velocity.

The unbroken specimens were subjected to  $K_{IC}$  evaluation by the procedure presented in References [16-18]. The fracture toughness is plotted as a function of impact velocity in Figure 9. The  $K_{IC}$  was found to be independent of impact velocity. Variation of  $K_{IC}$  in Figure 9 is attributed only to the experimental scatter. Values of  $K_{IC}$  are close to those given by the material's manufacturer in Table 1.

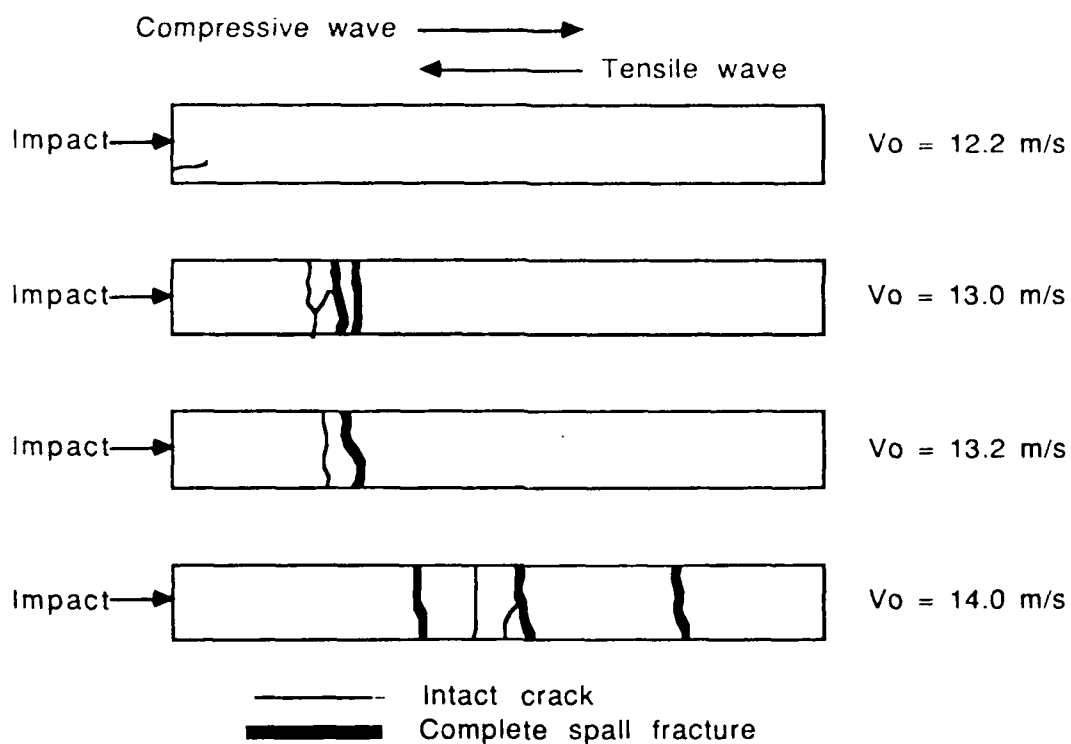
Figure 10, Map of macrocracking in impacted alumina bars.

Figure 10 maps the macrocracking found in the specimens which failed by complete spall. The alumina bars subjected to low velocity impact in this test did not exhibit the duration and magnitude dependency of failure. The specimen which did not fail at 12.2 m/s showed an unusual crack originating at the impact face. No other cracking was found in the intact specimens. The polished side surface revealed no wide spread microcracking when examined under the scanning electron microscope, but an uncommon microcrack was found originating at a pore (Fig. 11). This was the only microcrack found not associated with a spall fracture.

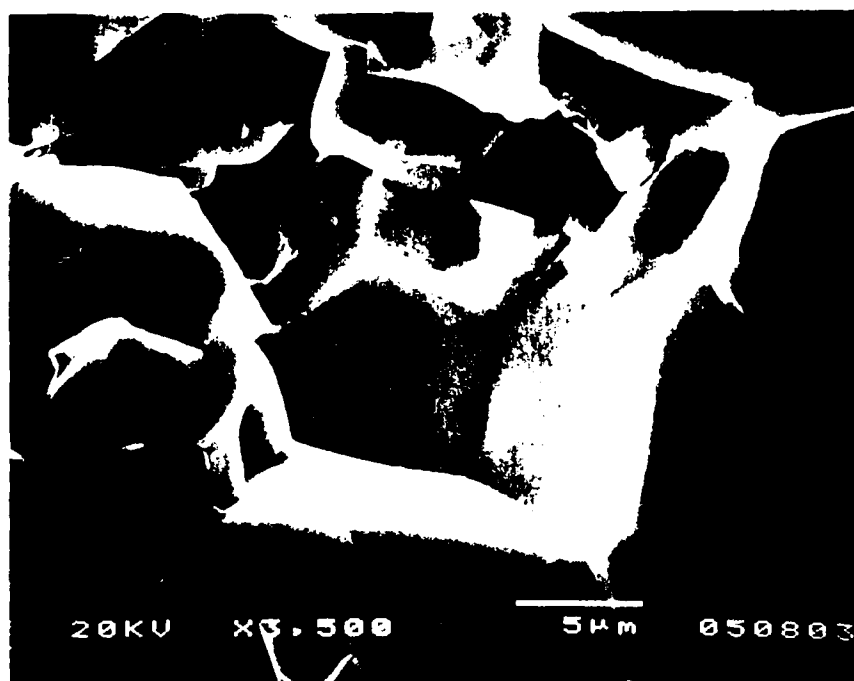
Figure 14, Intergranular crack (grain separation) in alumina; velocity = 14 m/s.
